ALAMEDA MUNICIPAL GARAGE

core Historic Structure Report

15 July 2011

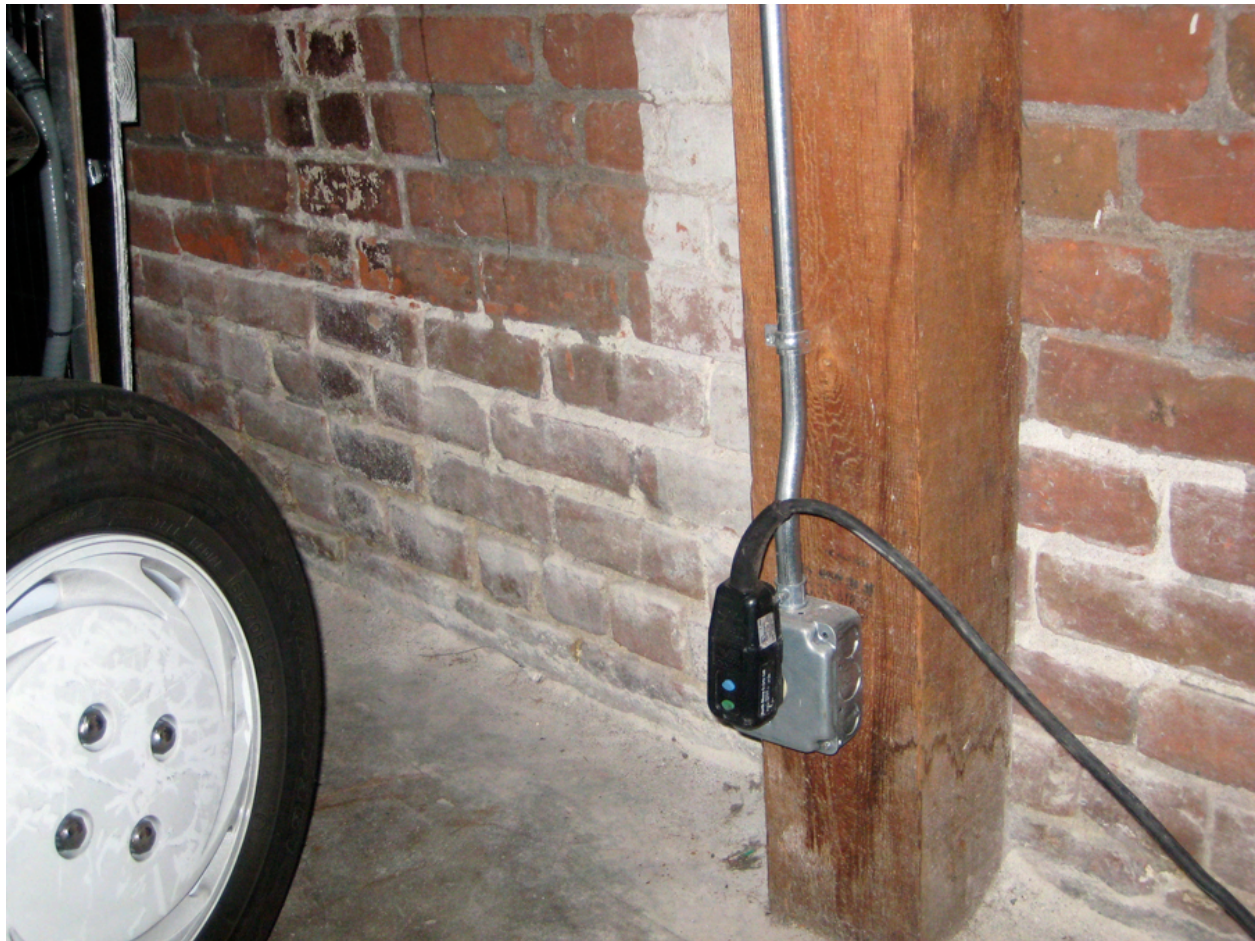
Figure 11. Efflorescence at grade in the main garage bay. (Photo by Garavaglia Architecture, Inc., 2011.)

often seen in masonry buildings as a white powdery buildup caused by salt leaching out of the mortar or concrete. This weakens the mortar and can weaken the surrounding masonry matrix as well. As salts crystallize, they expand, causing microcracking in the material. At the Municipal Garage, efflorescence is visible on the interior and the exterior brick walls, both at the base of the walls and near the roofline. This indicates that moisture is both rising up from the ground and infiltrating from the roof. In most areas this has resulted in degradation of the mortar from a solid material to a fine silt that can be blown out of the joints. In more severely affected areas, the bricks around the deteriorated mortar are soft, flaking and losing material integrity. Where the brick surfaces have been painted, the paint is bubbling, soft, and detaching from the wall.

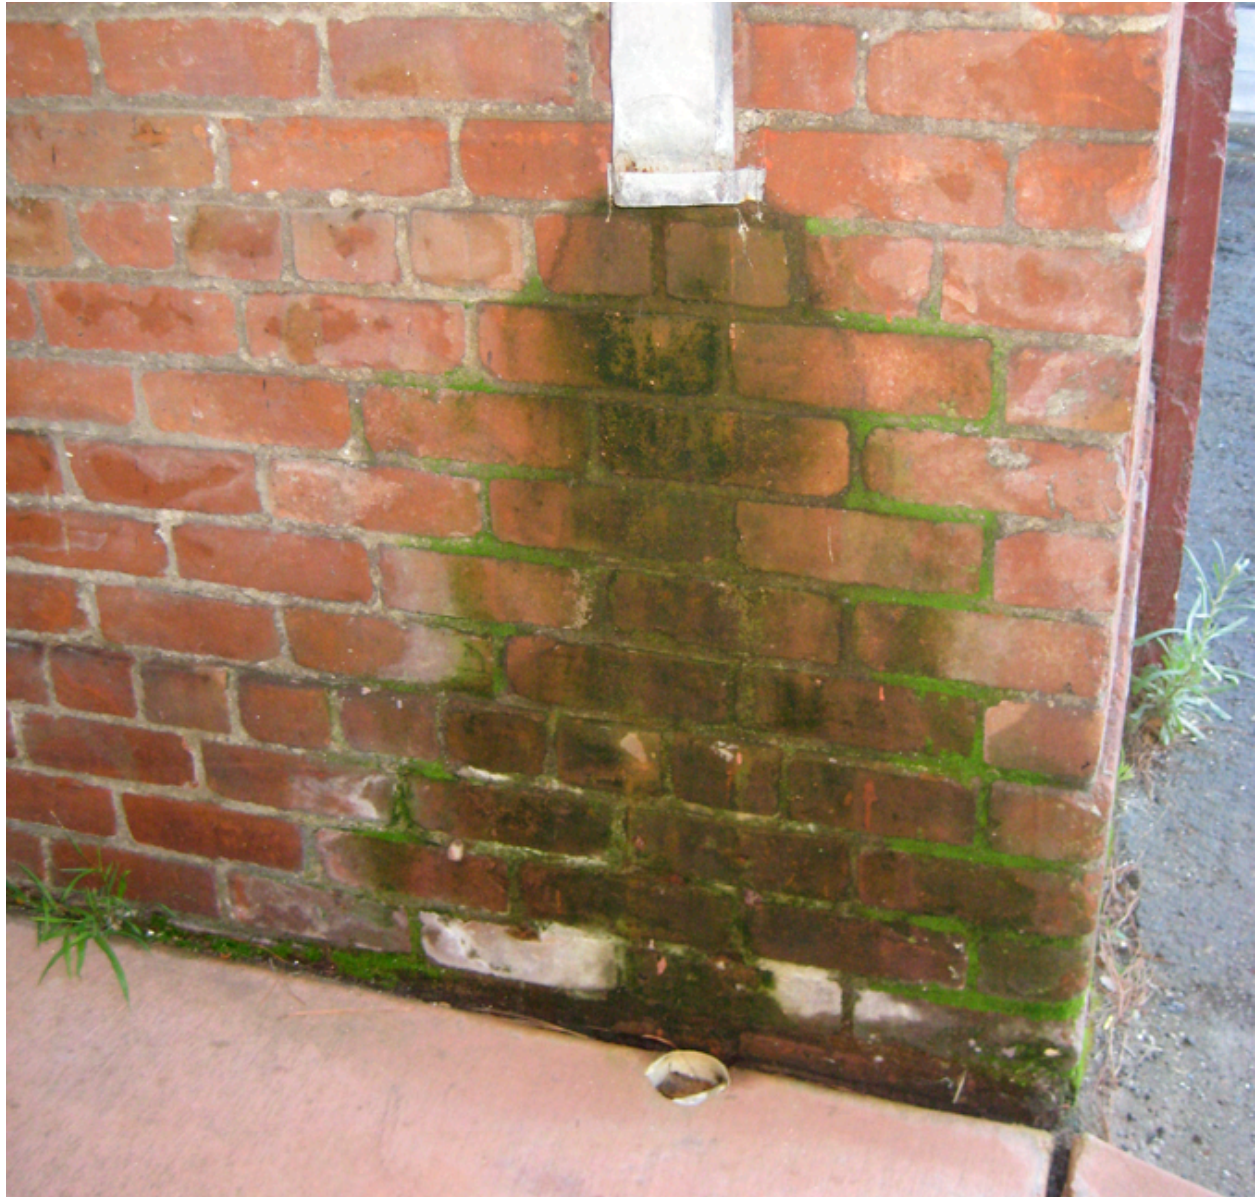
Figure 12. Biogrowth at downspout, south elevation. (Photo by Garavaglia Architecture, Inc., 2011.)

few months have exacerbated the condition, which appears in most areas as a green tint to the walls. This is true along the south parapet wall and at areas where downspouts are no longer keeping runoff away from the building surface. Areas that can hold more debris, such as the damaged cornice, tops of parapet walls, and roof-wall junctions, can support more robust plants.

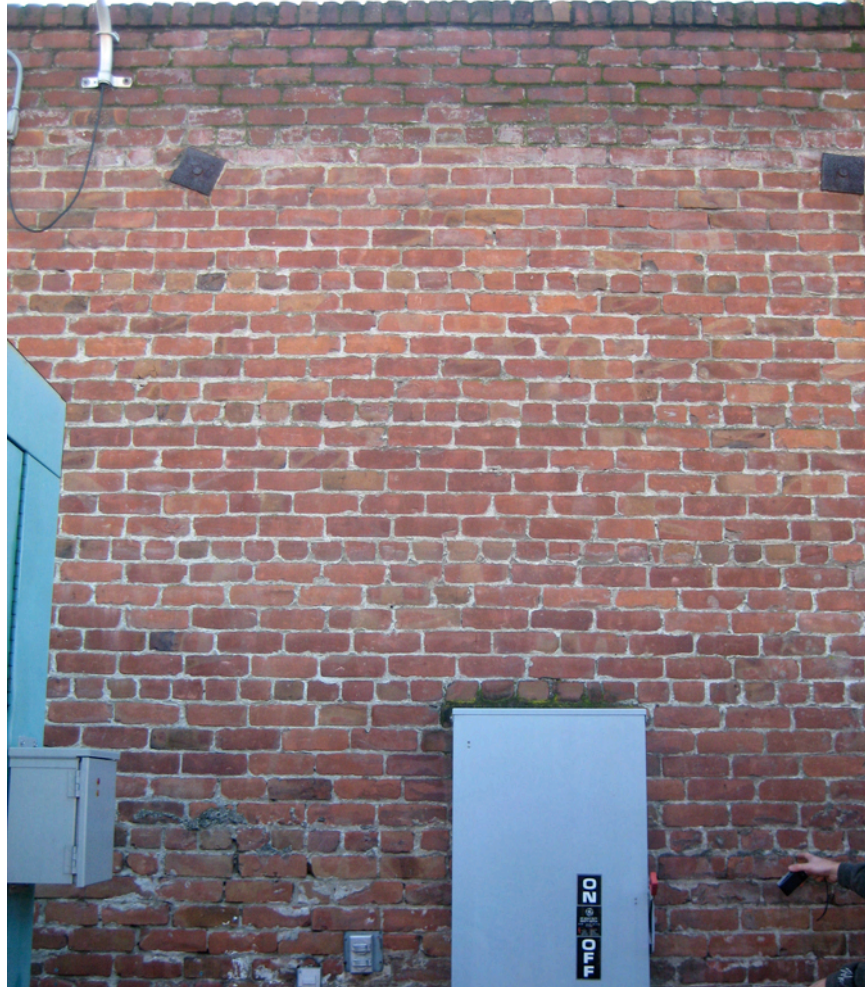
Figure 13. Exterior moisture staining at the top and bottom of the north exterior elevation. Missing mortar is a major concern on this elevation. (Photo by Garavaglia Architecture, Inc., 2011.)

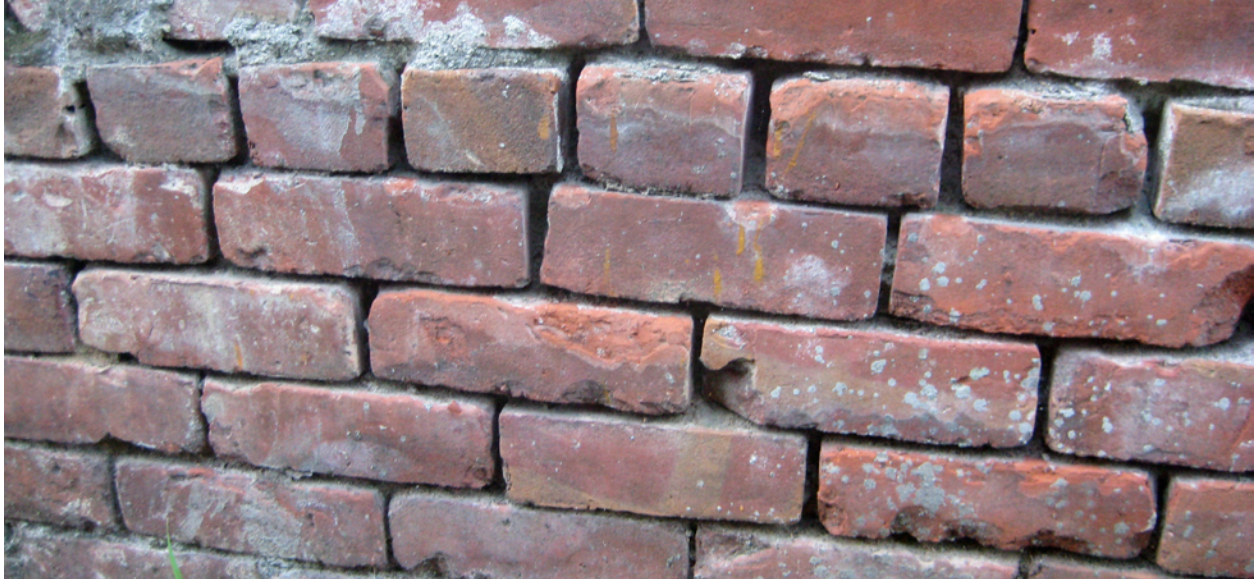
Figure 14. Missing mortar near grade on the north elevation. (Photo by Garavaglia Architecture, Inc., 2011.)

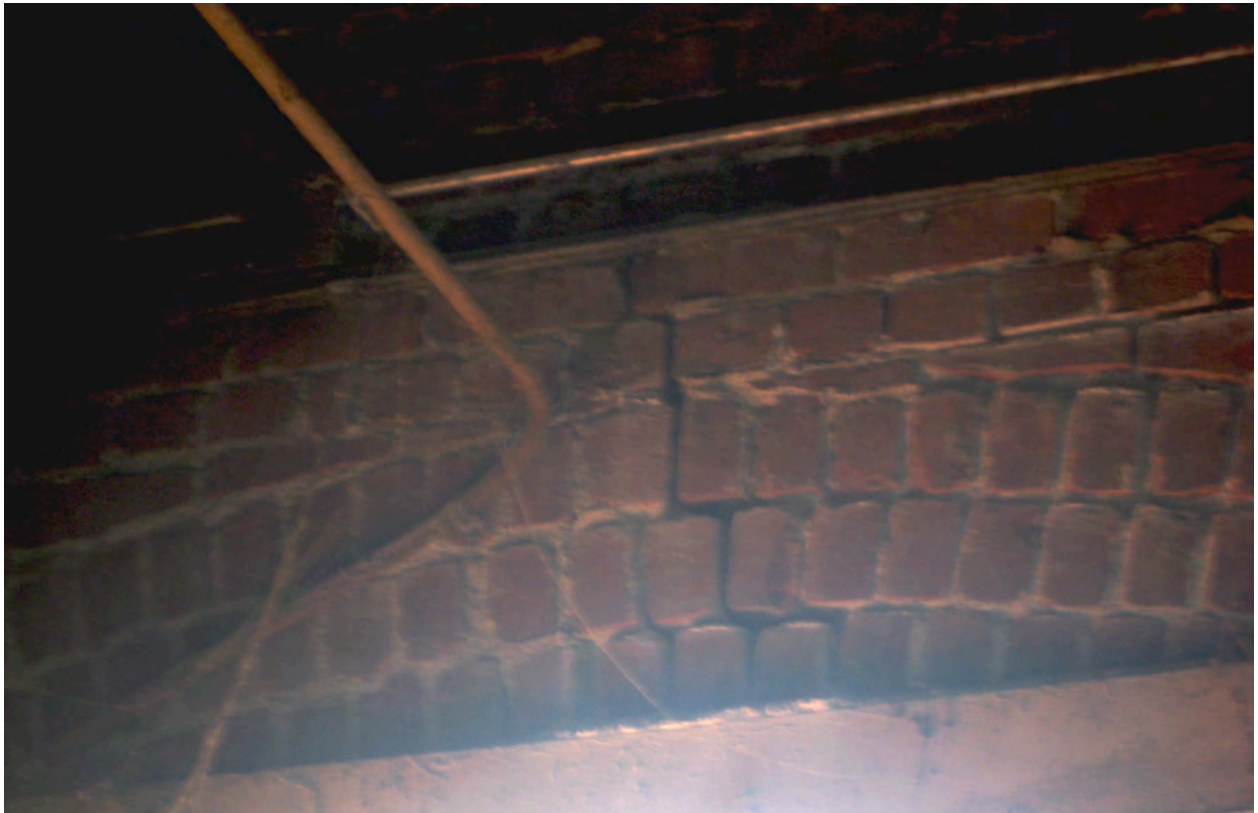
At the arched window headers, cracks extend through the headers, through both joints and bricks. This is a result of mortar loss and shifts in material. Some of this damage may be due to seismic activity but no widespread cracking of this type (long diagonal cracks at building corners) was observed.

Figure 15. Arched header mortar loss in Garage Room 1. (Photo by Garavaglia Architecture, Inc., 2011.)

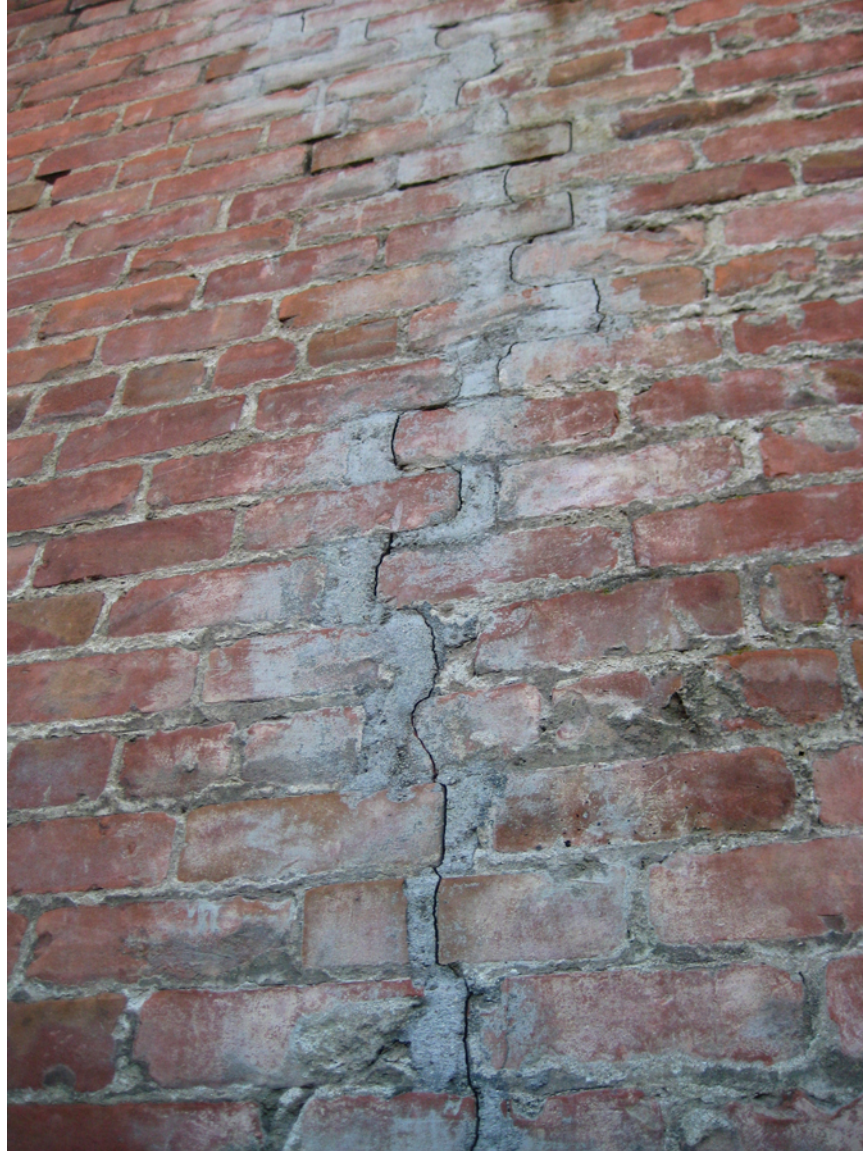
Cracking is rather limited throughout the building. On the north elevation, there is a long crack that travels almost the entire height of the wall. Some historical accounts describe an addition to the building early in its existence; it is possible that this crack may mark the boundary of the addition. Alternatively, differential settlement in the two foundations, over time, may result in a crack like this one.

Figure 16. Crack in north elevation. This crack is the full height of the wall and extends through the wall width. (Photo by Garavaglia Architecture, Inc., 2011.)

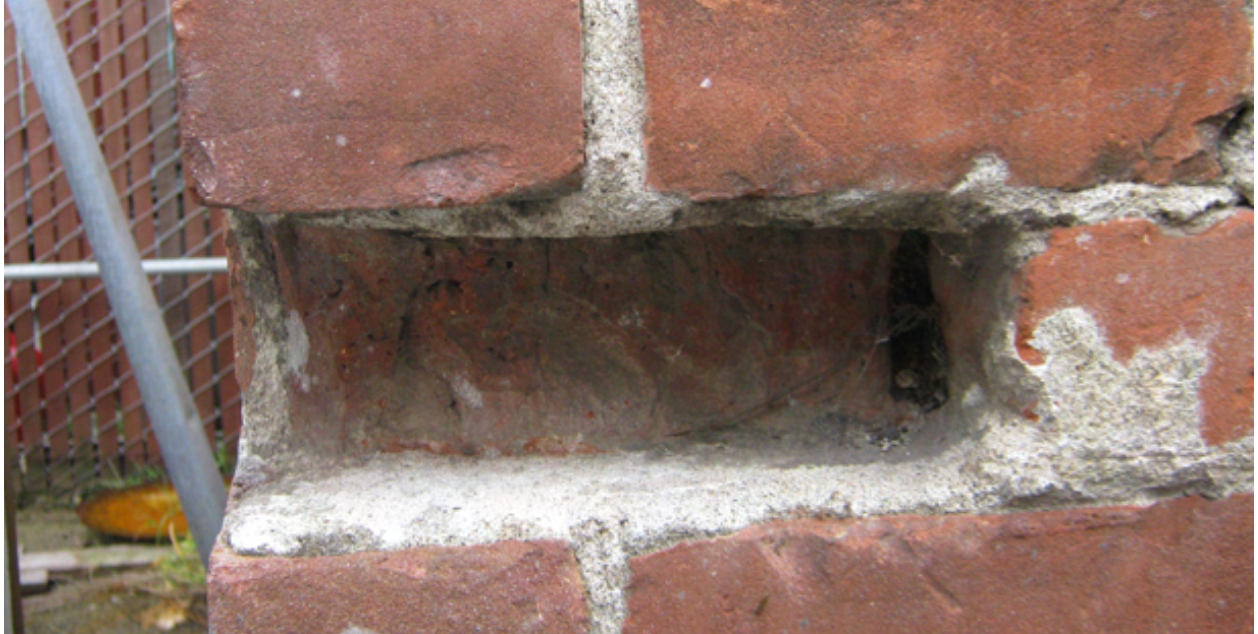
The north wall has a void through two wythes of brick, presumably from a former vent or pipe location. Throughout the building, single bricks have been replaced with a dark, non-historic mortar. In one case, the brick was left missing (west elevation, northwest corner). These indicate that shear testing was conducted at some point in the past. This was likely done in conjunction with the rehabilitation of City Hall in the 1990s. While no damage was observed from these repairs of former voids, all voids and improper repairs should be addressed during the eventual rehabilitation of the structure. Testing of the mortar should be done prior to repairs to determine an appropriate mortar mix.

Figure 17. Missing brick at west elevation. This is likely a shear test location dating to the rehabilitation of City Hall in the 1990s. (Photo by Garavaglia Architecture, Inc., 2011.)

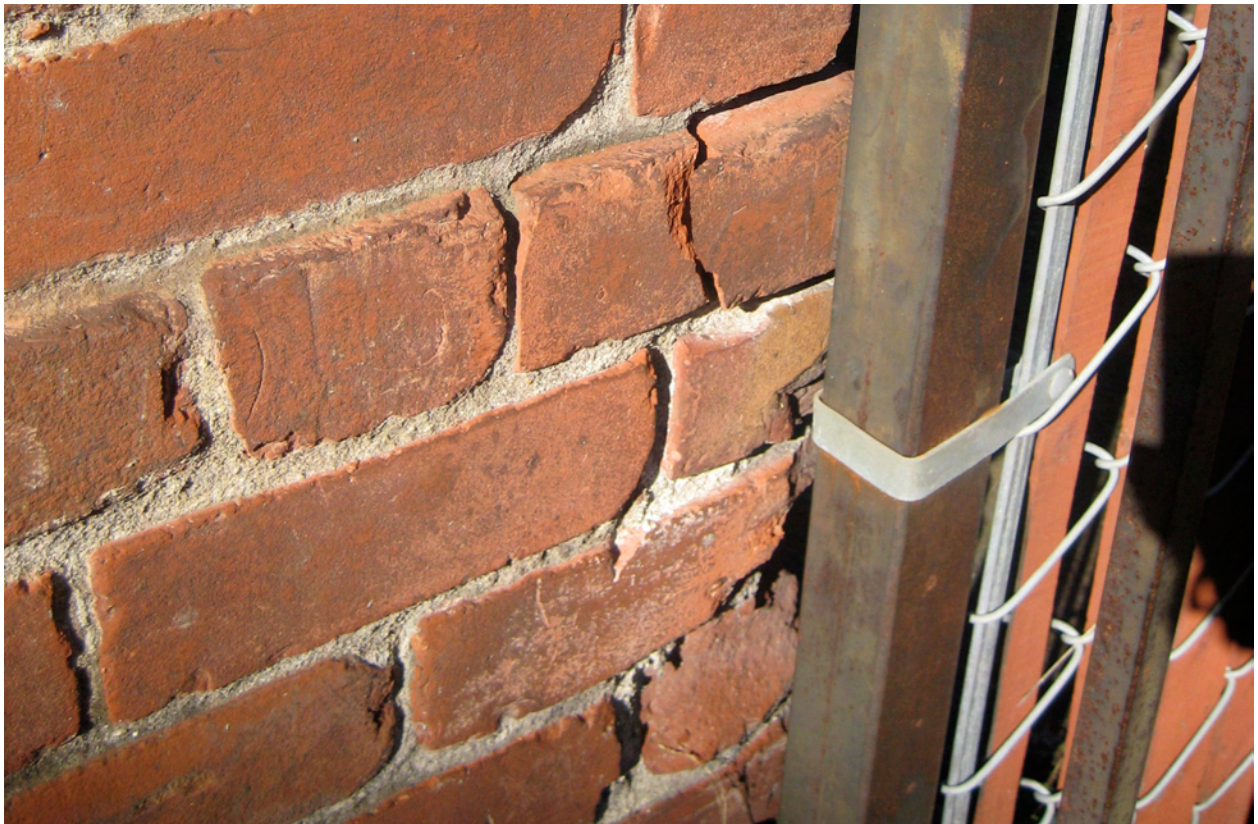
Figure 18. Northeast corner impact damage. Note the jagged brick corners and missing material. (Photo by Garavaglia Architecture, Inc., 2011.)

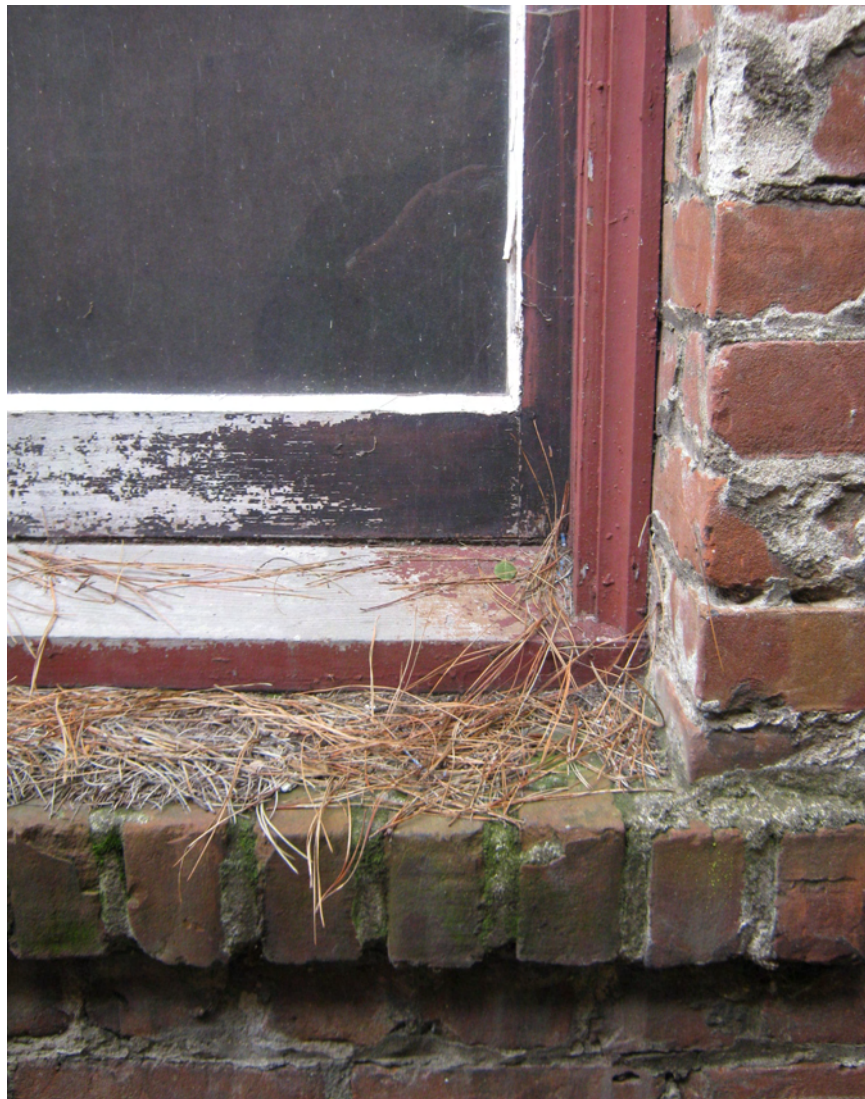
The windows throughout the building are in need of general maintenance now to prevent more serious, structural damage later on. While most of the glazing is intact, the glazing putty is dry, cracked, and sometimes missing. This condition will allow the glass to fall out and break with slight movements. It also allows moisture to get behind the glass and into the narrow channels

Figure 19. Typical window condition with unpainted sashes and cracked putty. (Photo by Garavaglia Architecture, Inc., 2011.)

where the glass sits in the frame. Because these frame elements are often of narrow cross-section, highly decorative or have delicate joints, moisture damage will progress rapidly and the integrity of the window could be lost relatively quickly.

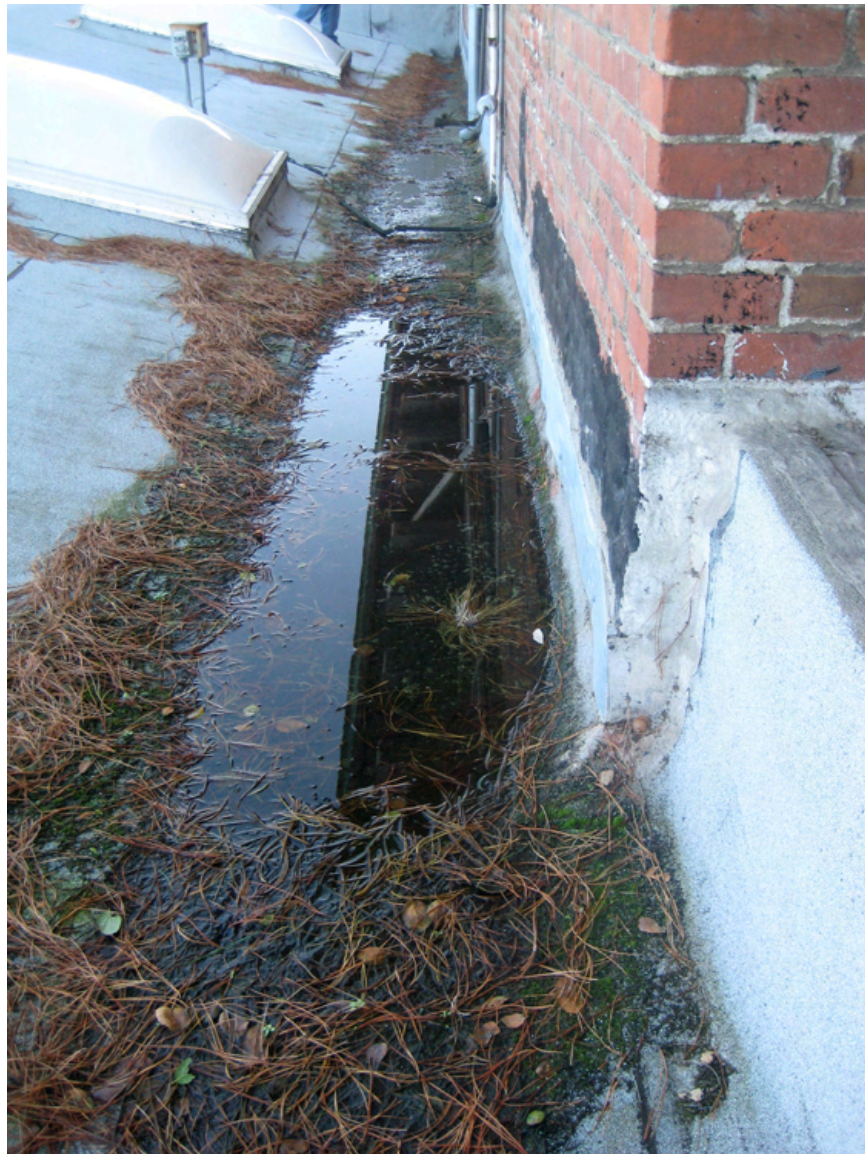
Figure 20. Ponding at the junction with the two-story wall. (Photo by Garavaglia Architecture, Inc., 2011.)

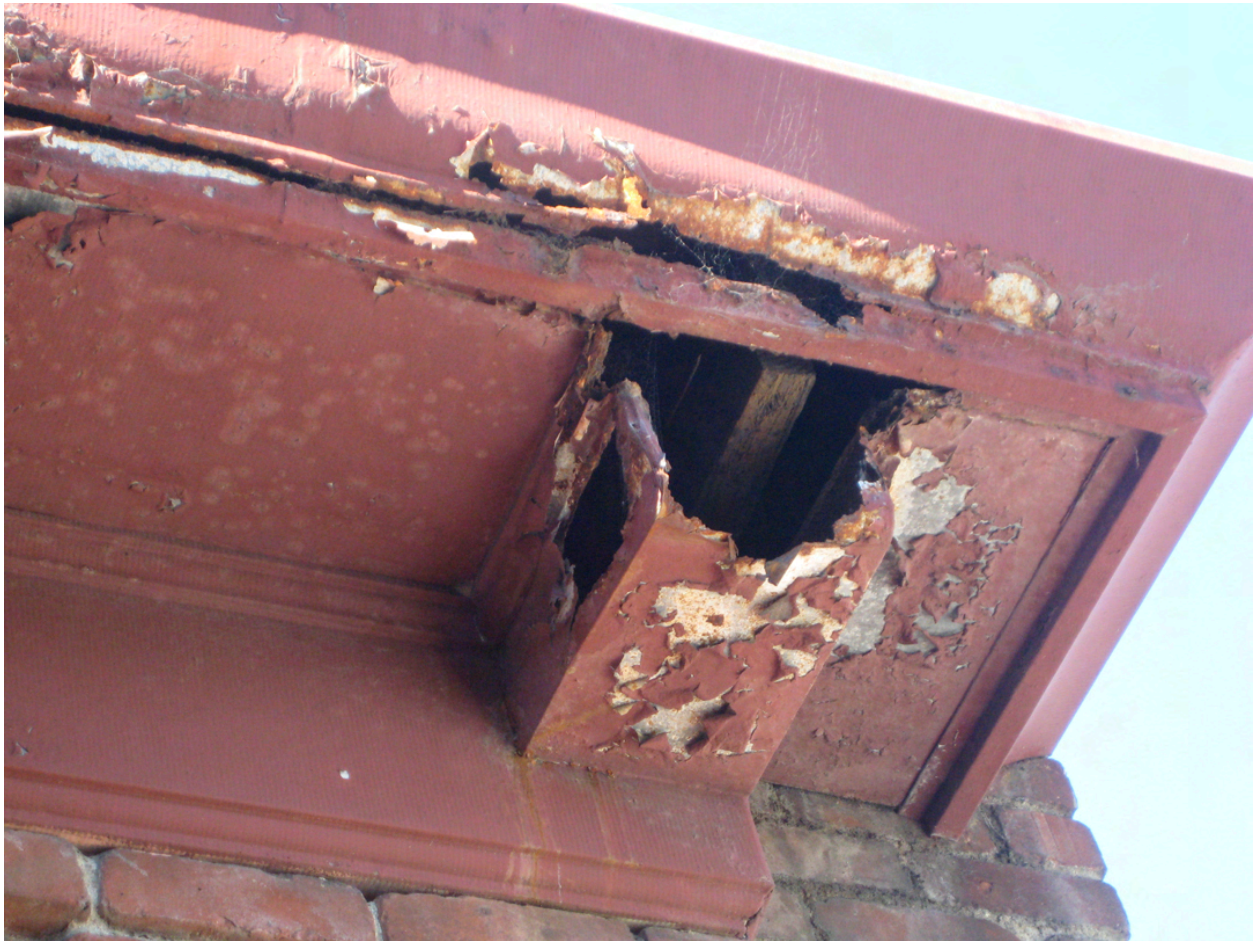
Figure 21. Detail of a standard cornice condition. (Photo by Garavaglia Architecture, Inc., 2011.)

The pressed metal cornice is severely deteriorated. Large voids are clearly visible from the ground. Holes in the cornice not only accelerate damage of the cornice itself, but also allow moisture to penetrate the wood framing structure supporting the cornice and roof. On the metal awning roof, voids allow water to contact the framing structure, causing structural damage. The tails of the rafters are splitting and it appears the roof is slightly sagging at mid span. One of the diagonal supports is sliding out of its support notch.

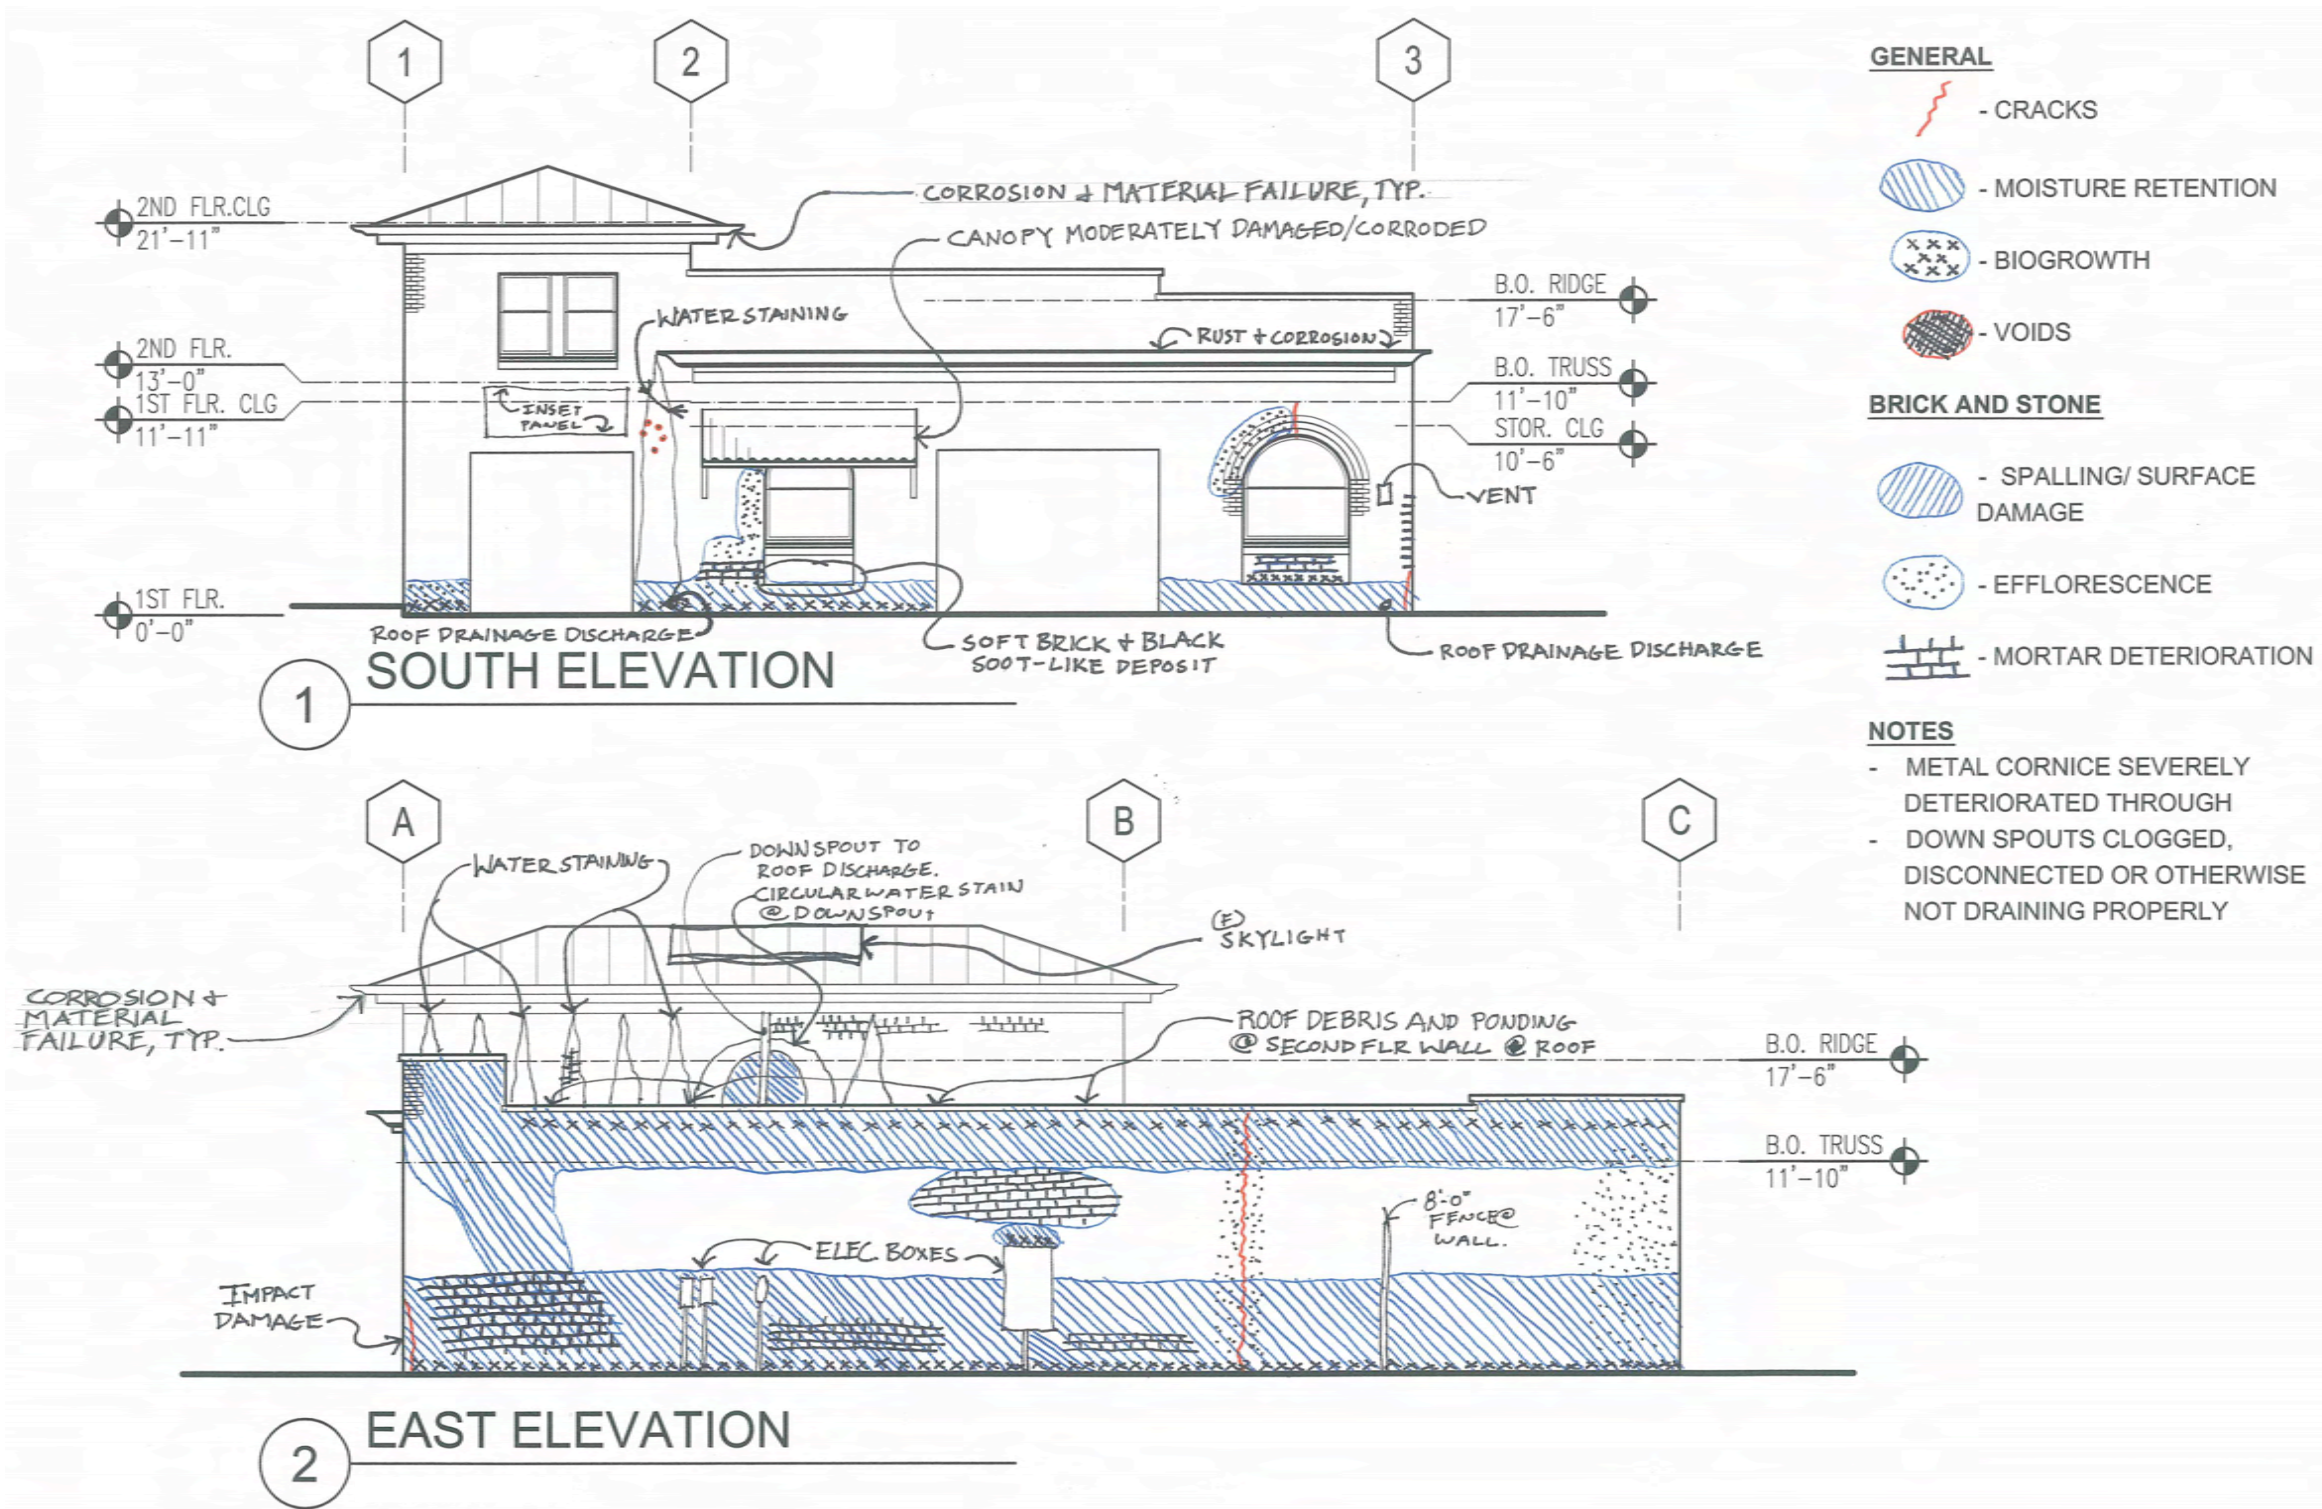
Figure 22. South and East Elevations, conditions assessment diagrams. Conditions were noted in January 2011 at the height of a long period of wet weather. (drawings not to scale).

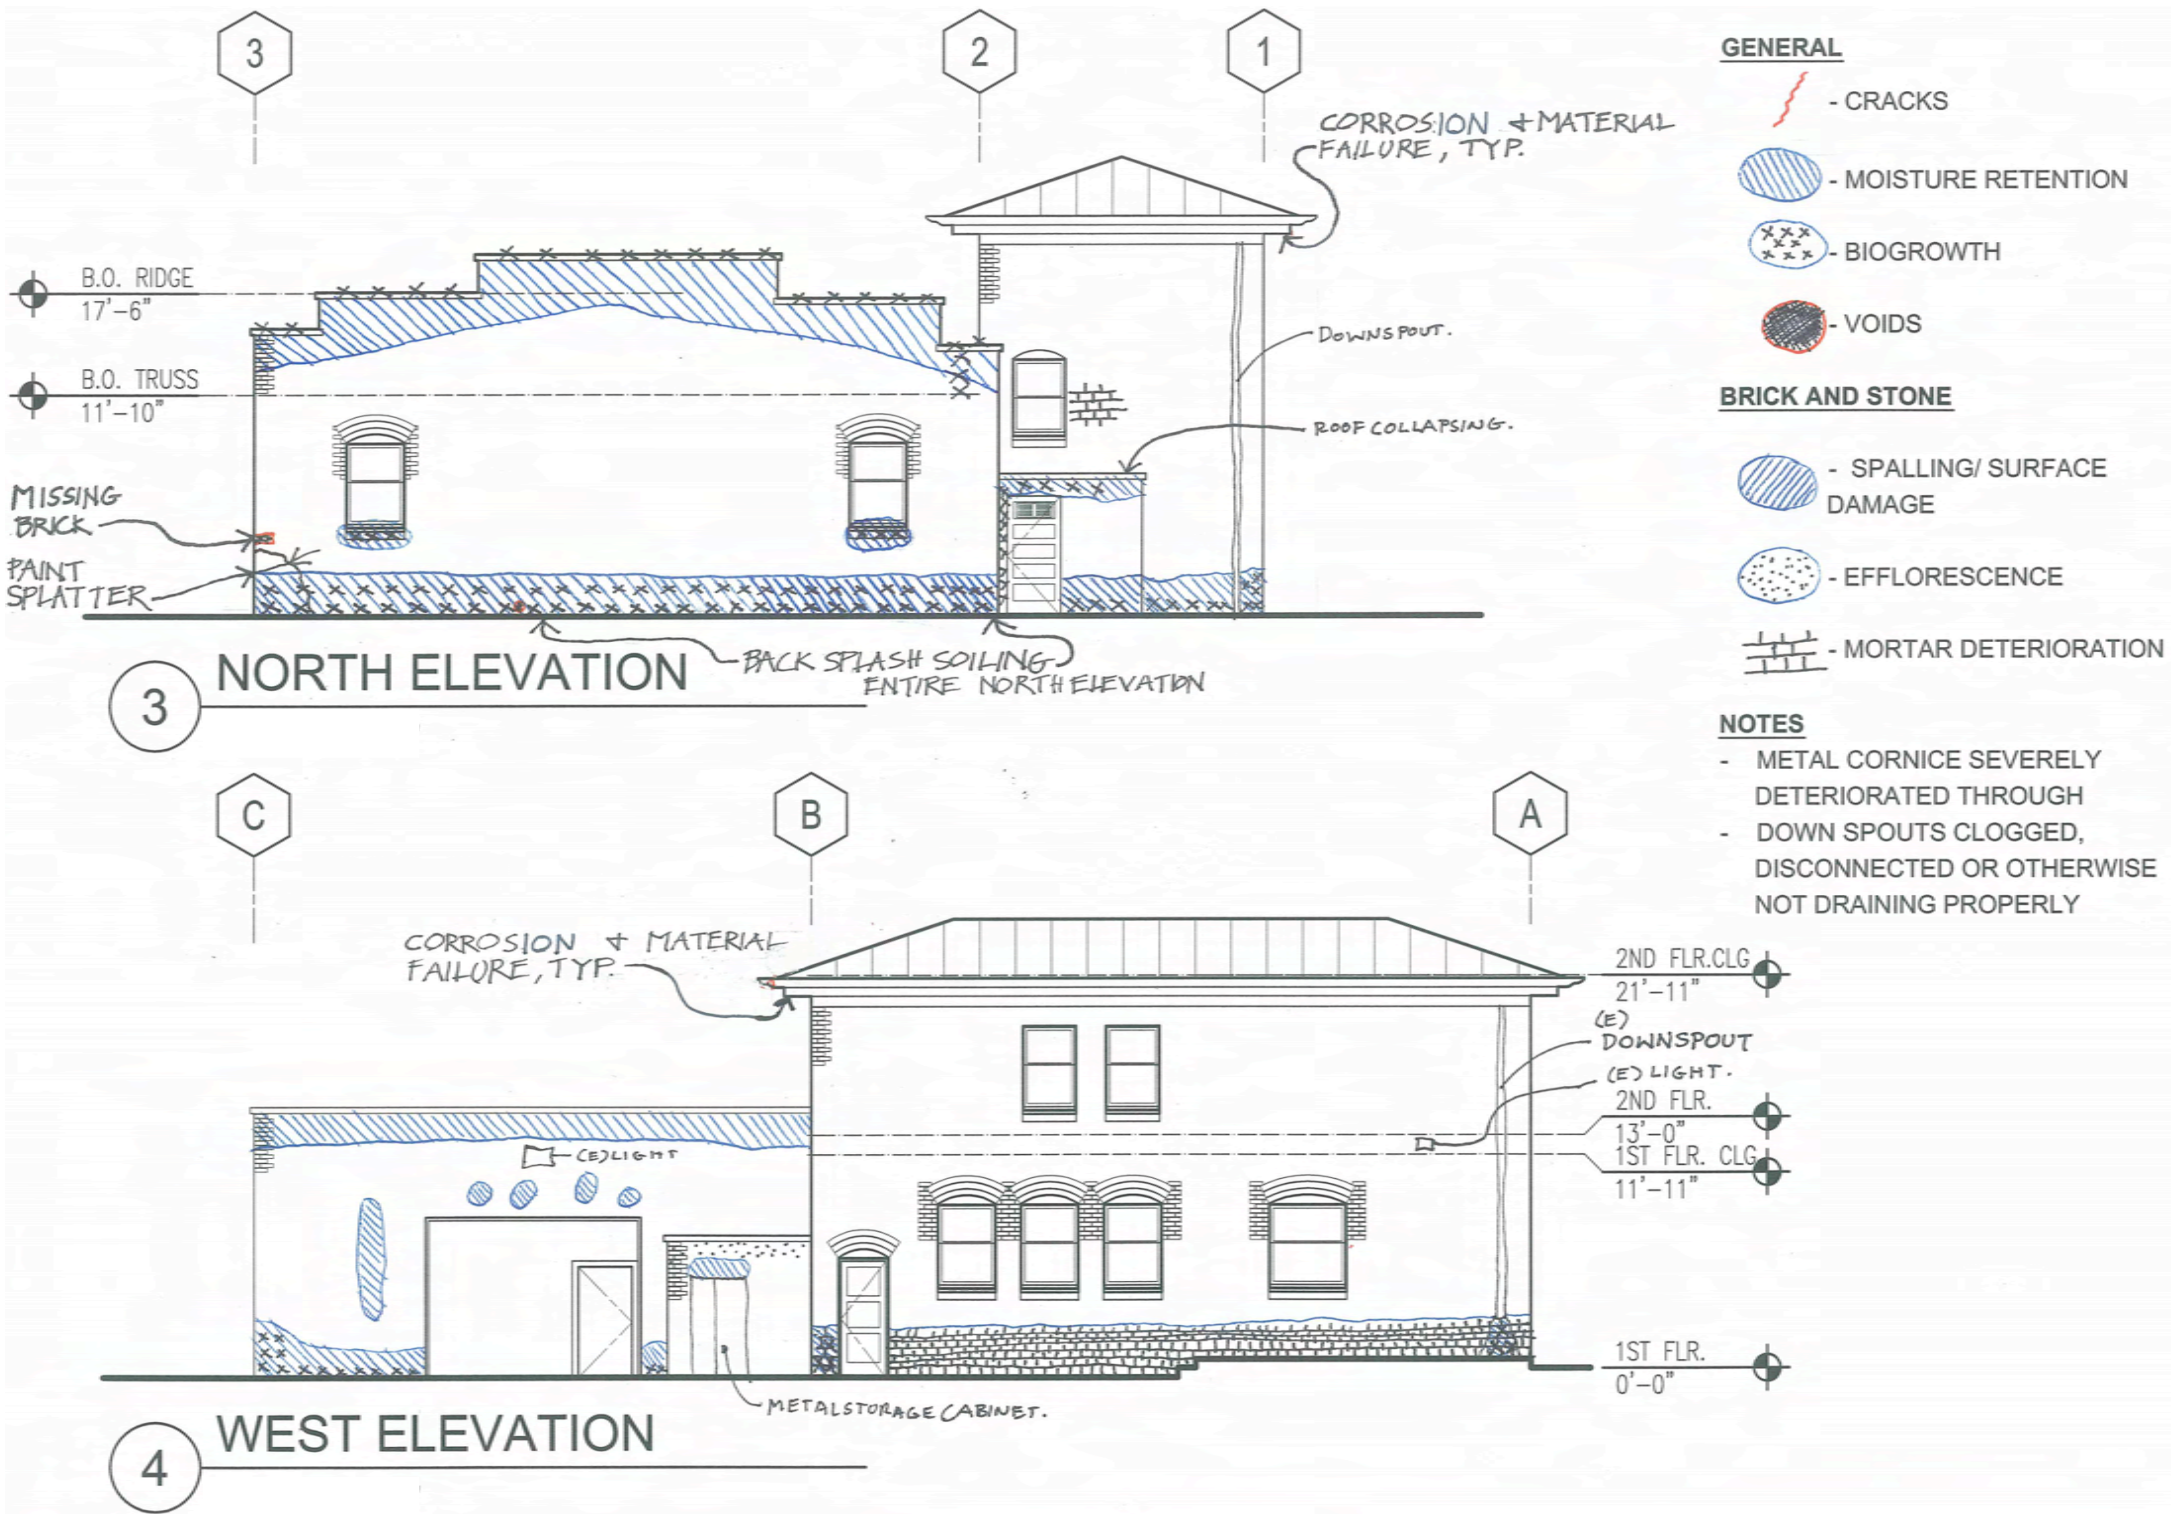
Figure 23. North and West Elevations, conditions assessment diagrams. Conditions were noted in January 2011 at the height of a long period of wet weather. (drawings not to scale).

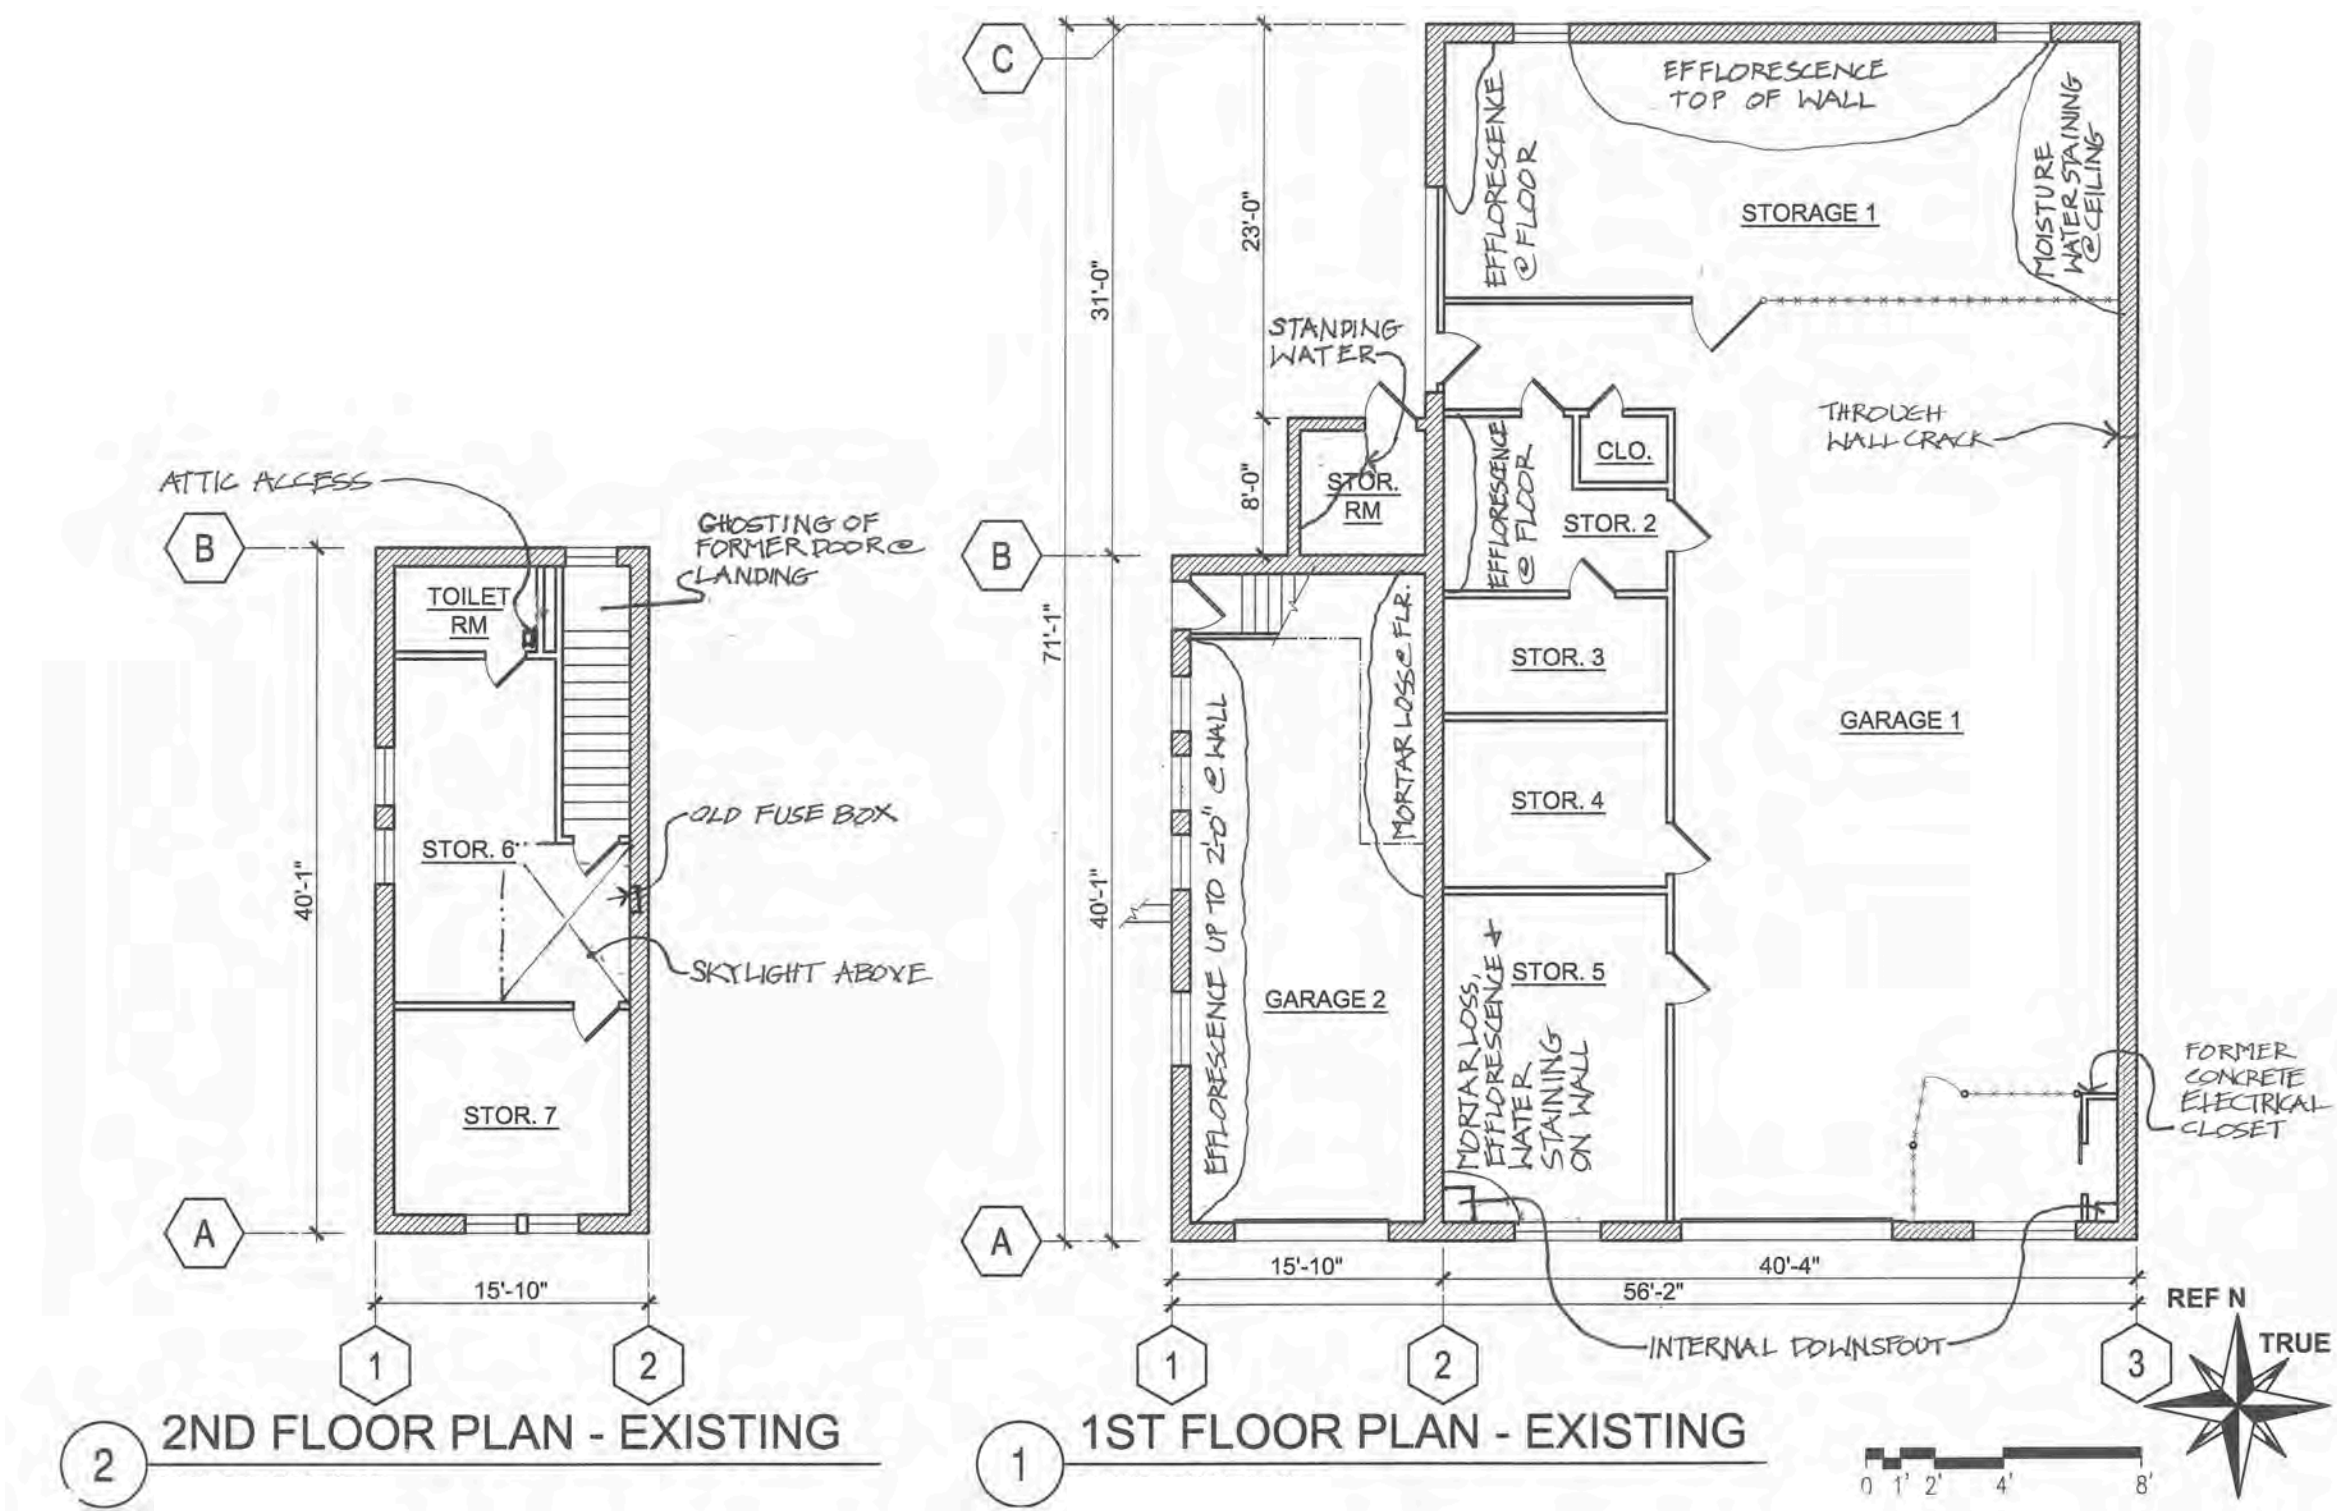
Figure 24. 1st and 2nd floor plans, conditions assessment diagrams. Conditions were noted in January 2011 at the height of a long period of wet weather. (drawings not to scale).
